**Flood Control Project Maintenance
Levee Inspections**
LMA District Cover Sheet
Spring 2010 Levee Inspection Results

Sutter Maintenance Yard Tisdale Bypass

Spring 2010 Levee Inspection Results

Levee Inspection Report By Mile - Spring 2010

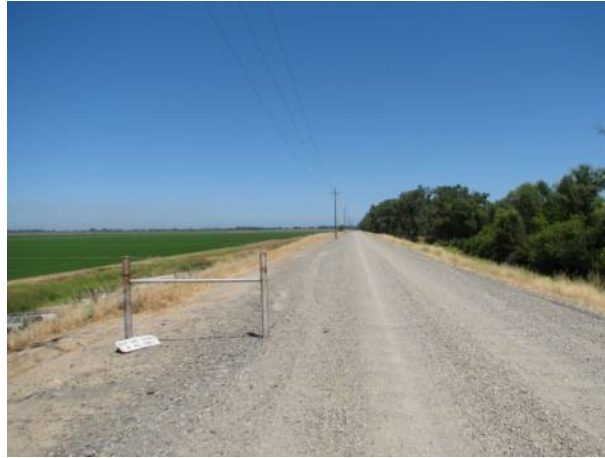
Levee Mile Report Line	1
Start Levee Mile	2.18
End Levee Mile	4.10
Location	Land Side
Category	Earthen Levee
Item	Encroachments

LMR No	Levee Mile		Category	Item	Location *	Rating **	Action/Comment	GPS Latitude/Longitude		Issue No. Photo
	Start	End						Start	End	
1	2.18	4.10	Earthen Levee	Encroachments	LS	PO	Poles	39.028173 ° -121.781475 °	39.028012 ° -121.745665 °	3 Y

View of the PG&E poles along the landside crown of the levee.

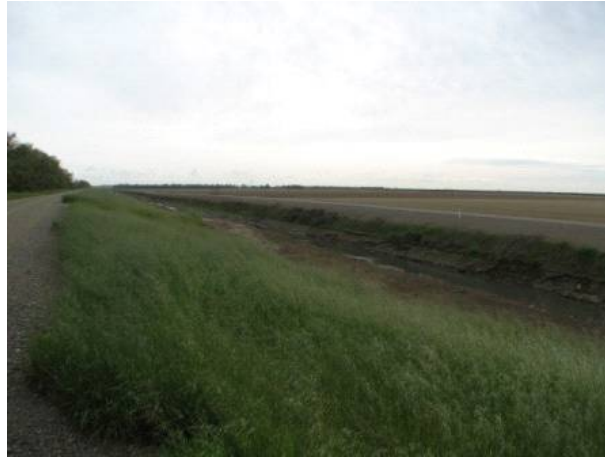
Levee Mile Report Line	1
Start Levee Mile	0.11
End Levee Mile	0.25
Location	Land Side
Category	Earthen Levee
Item	Encroachments

View of the agriculture ditch and erosion along the landsite toe of the Levee.

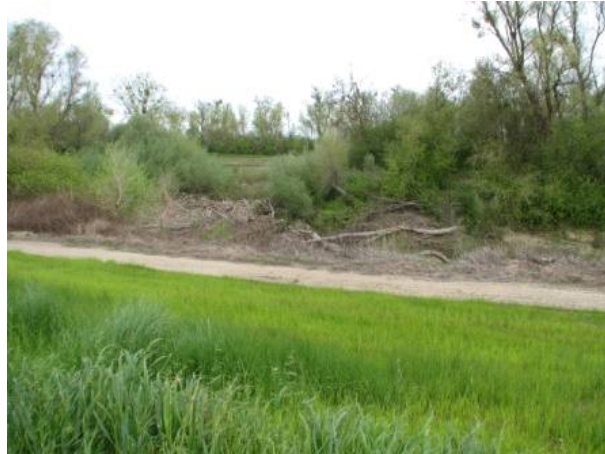
Levee Mile Report Line	3
Start Levee Mile	1.01
End Levee Mile	1.01
Location	Water Side
Category	Earthen Levee
Item	Erosion / Bank Caving

View of the erosion along the waterside toe of the levee.
